Impact of Cyclone Yasi on the Wreck of the *SS Yongala* Documented by Comparative Multibeam Bathymetry Analysis

Thomas C. Stieglitz^{1,2} and Paddy Waterson³

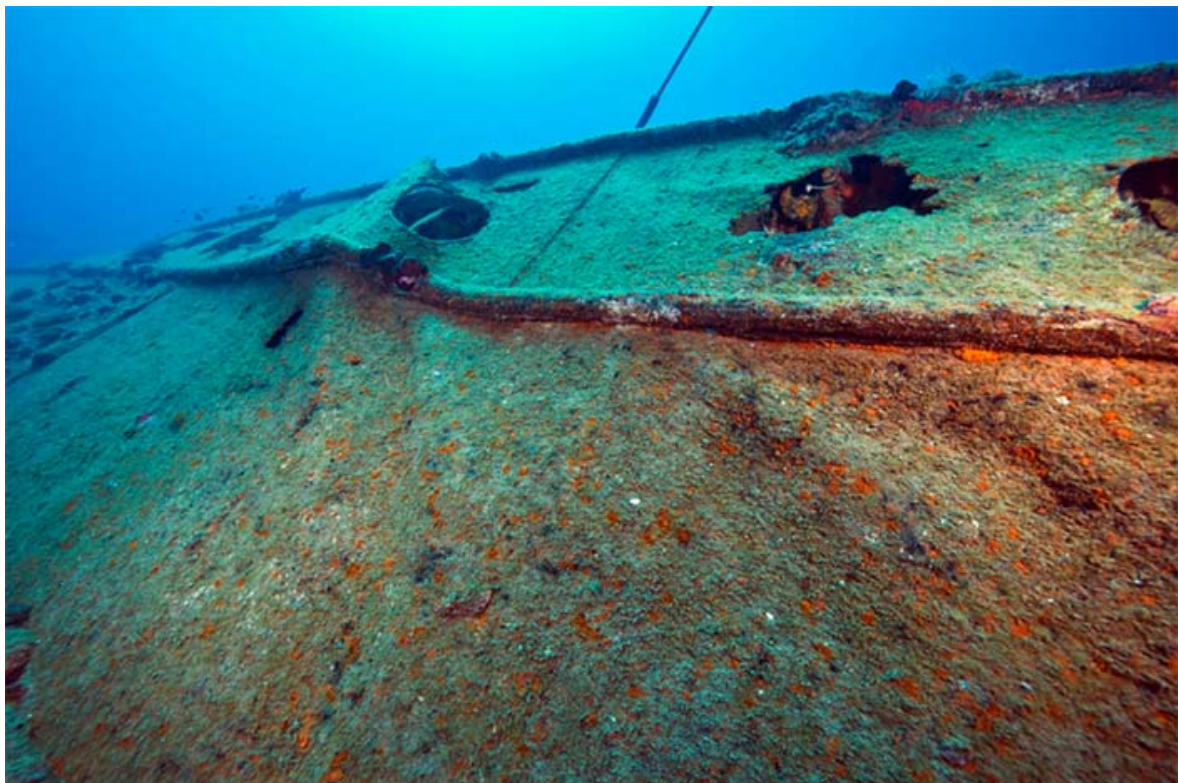
Figure 2. Hull buckling and warping is clearly visible in dive inspections after Cyclone Yasi's passage (Photograph: David Wachenfeld, Triggerfish Images).

17 July 2012) has further estimated the 'to-and-fro' water movement across the surface of the wreck to be 5m per second or 10 knots. Initial reports from divers indicated that the wreck of the *SS Yongala* had received significant permanent damage to its structure (Figure 2). A preliminary site inspection by a government dive team confirmed the high degree of impact by visual observations, but the size of the wreck (c.110m in length), the low visibility and relative depth complicated the collection of quantifiable data on the scale of impact (Waterson 2012).

Post-Yasi dive inspections (not reported in detail here) are consistent with the assessment of multibeam data. Visual inspections by divers provided important supplementary information on conservation issues (e.g. areas of active corrosion) and identified specific structural elements, which although at a smaller spatial scale, facilitated a more nuanced understanding of structural decay and physical changes. Divers immediately observed signs of stress and fatigue at the outer hull (e.g. Figure 2).

Numerous openings have appeared where benthos has been removed exposing either pre-existing corrosion holes or paper thin metal to the highly corrosive environment. Where metal integrity is relatively high, stress forces have created buckles or ripples in the hull (G. Hewitt, pers. comm., 10 September 2012). In sections, cracks are running across the deck from port to starboard, while in others the hull plating is separating. The openings to the two forward holds have buckled, and sections of the central deck citadel have collapsed, causing some materials to fall onto the adjacent seafloor. In both multibeam and visual observations, the forward section of the wreck's upper port side showed the most obvious signs of physical stress, with buckling and warping of the exposed metal hull (Figure 2). It is interesting to note that visual inspection revealed significantly more coral concretions remaining on the aft section compared to the upper centre and forward sections, which have been left virtually bare by Yasi, possibly indicating smaller impact by shear forces towards aft. However it is possible that the poor ductility of hard-bodied epifauna and concretions also contributed, and that their loss was proportional to the level of movement in the hull's shell plating (G. Hewitt, pers. comm., 10 September 2012).

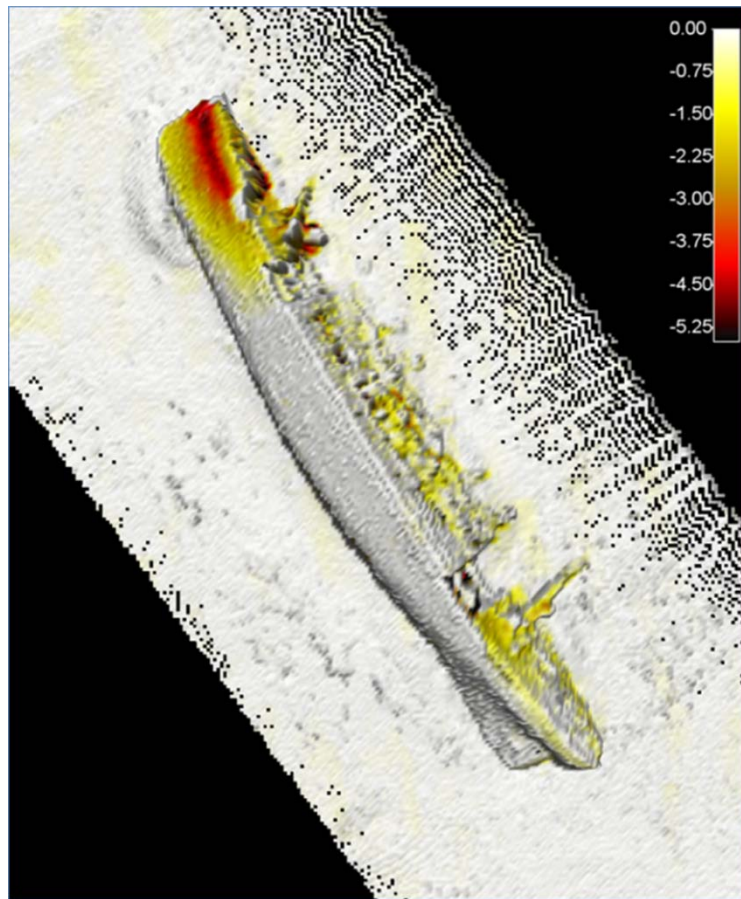
The most pronounced changes occurred in a c.35m-long section forward of the first cargo hold (highlighted in red, Figure 4). The bow at its tip has dropped in height by just over 5m. The forward section of the hull has rotated towards the east, with a pivot point located 35–40m aft of the bow (Figures 5–6). Hull cross-sections X11 to X14 in Figure 6 provide a quantitative determination of this rotation around the wreck’s axis.

The results of the survey and the impacts of the cyclone are clearly illustrated in 3D images (Figures 7–8). The main body of the wreck amidships is in the same position as pre-Yasi and appears to be largely stable (Figures 4, 6). Impacts in the centre of the ship have been largely restricted to the exposed deck levels and superstructure (Figure 7). For example, the forward derrick mast is now at a less pronounced angle to the ship’s deck (Figure 7), consistent with the identified twisting and rotation of the forward section of the ship. The stern of the wreck has only slightly dropped (Figures 4, 7). Cross-sections X03 to X05 (Appendix A),

Figure 4. Plan view of difference in depth between 2004 and 2011 shoal-biased grid data (i.e. difference between the datasets shown in Figure 3), draped over the 2011 bathymetry data. The colour code denotes changes in meter for each grid cell. Red colours indicates largest changes between data sets at the bow section.

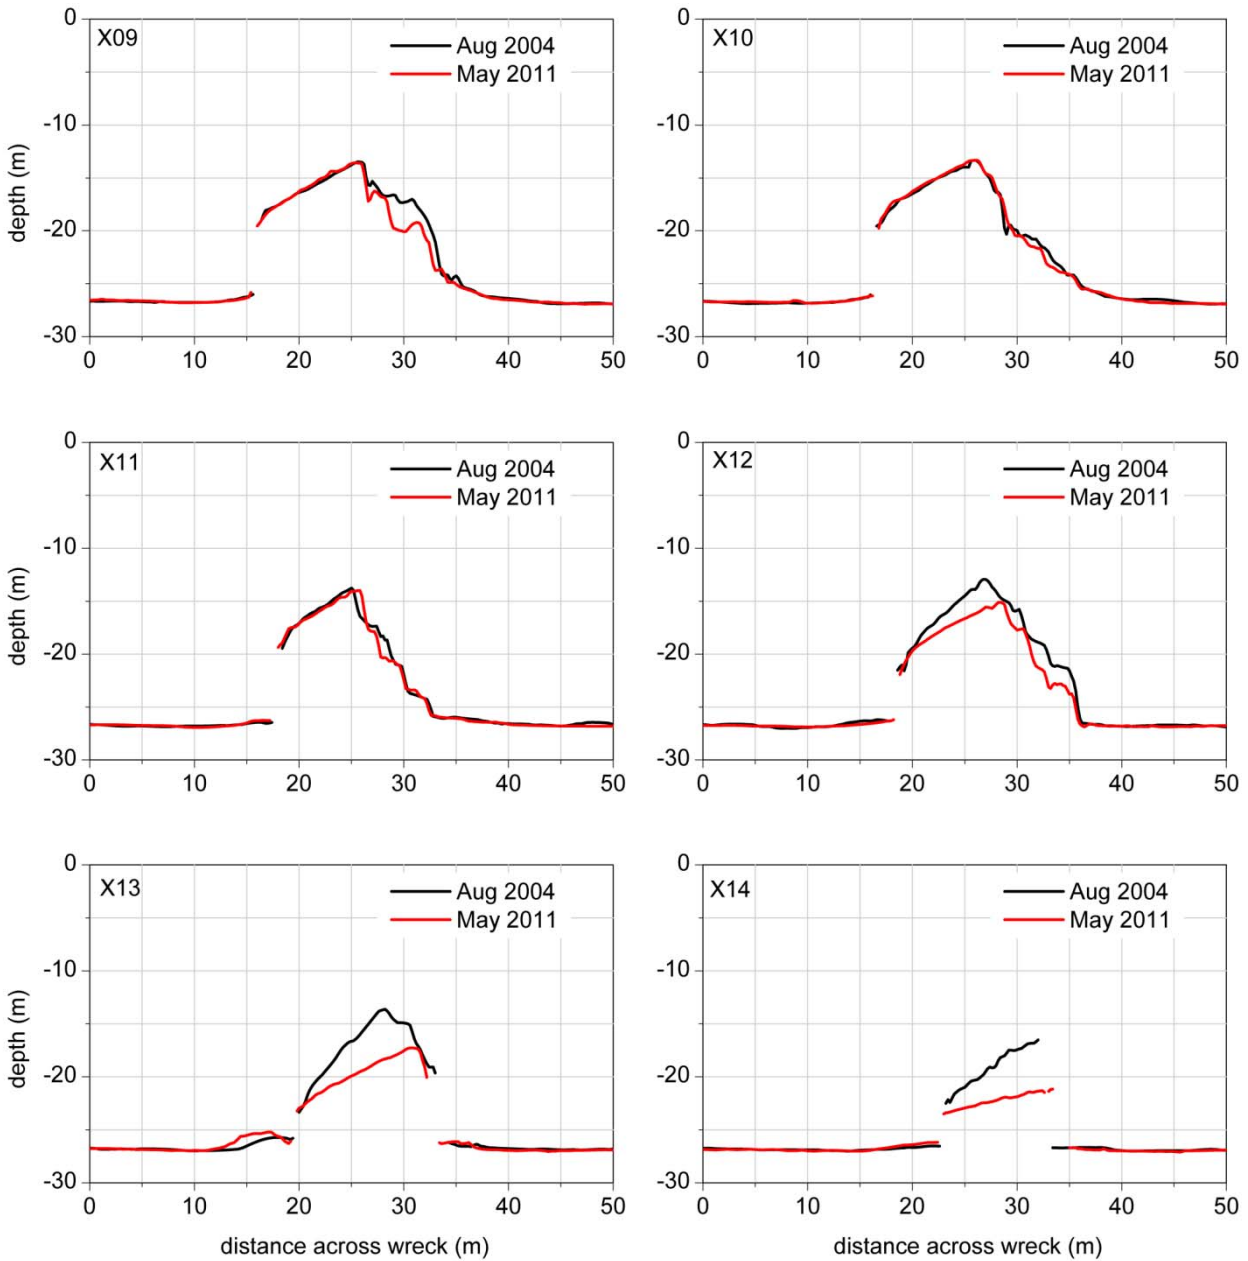
Figure 6. Quantitative comparison of wreck morphology in sections across the hull forward from the centre of the wreck (X09–X14). Cross-sections are drawn from SW to NE. The rotation and drop of the bow section is evident in sections X11–X14. For completeness, all sections X01–X16 are shown in Appendix A.

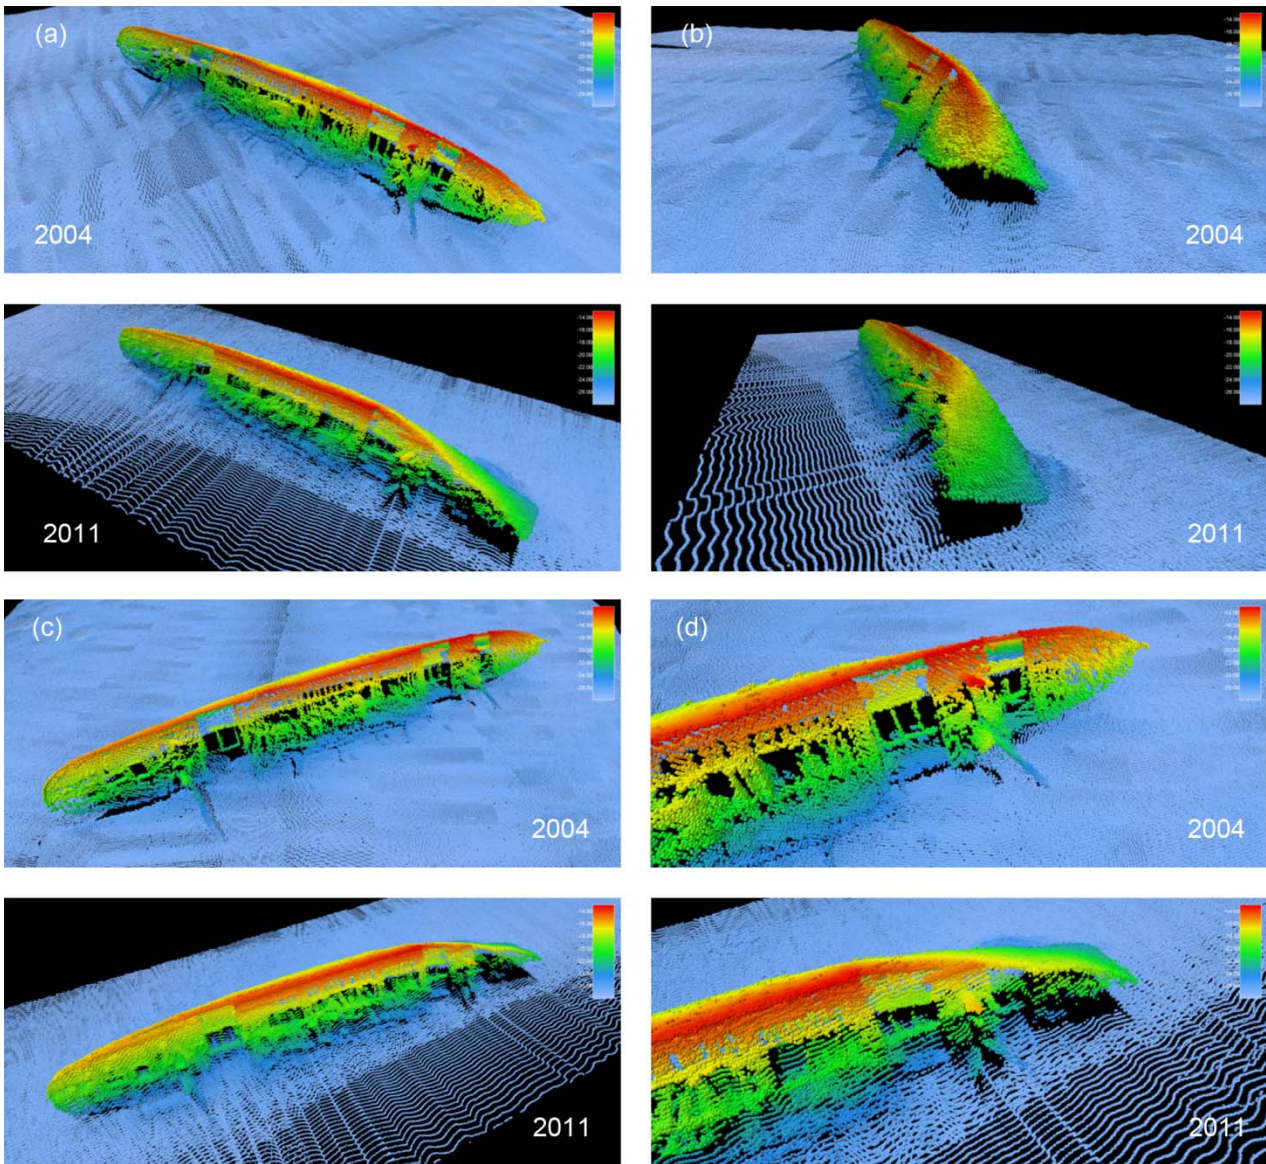
The survey also produced clear evidence of debris fields surrounding the wreck (Figure 8). A substantial number of new meter-scale positive bathymetric features were identified, especially to the west and southeast of the main wreck. New features are also evident along the base of the deck level (Figure 7), likely a combination of exposed wreckage and superstructure damaged during the storm.

Figure 7. Qualitative comparison of 3D point cloud data. 3D view from (a) ENE, (b) N and (c & d) E respectively. The rotation and drop of the bow section and rearrangement of forward masts/stacks are prominently visible. In addition, a small difference is noticeable at the stern section: the deck part has slightly dropped (compare colour in (c)). At the stern, the difference in sounding density of the superstructure may preclude or mask the detection of some small-scale changes.

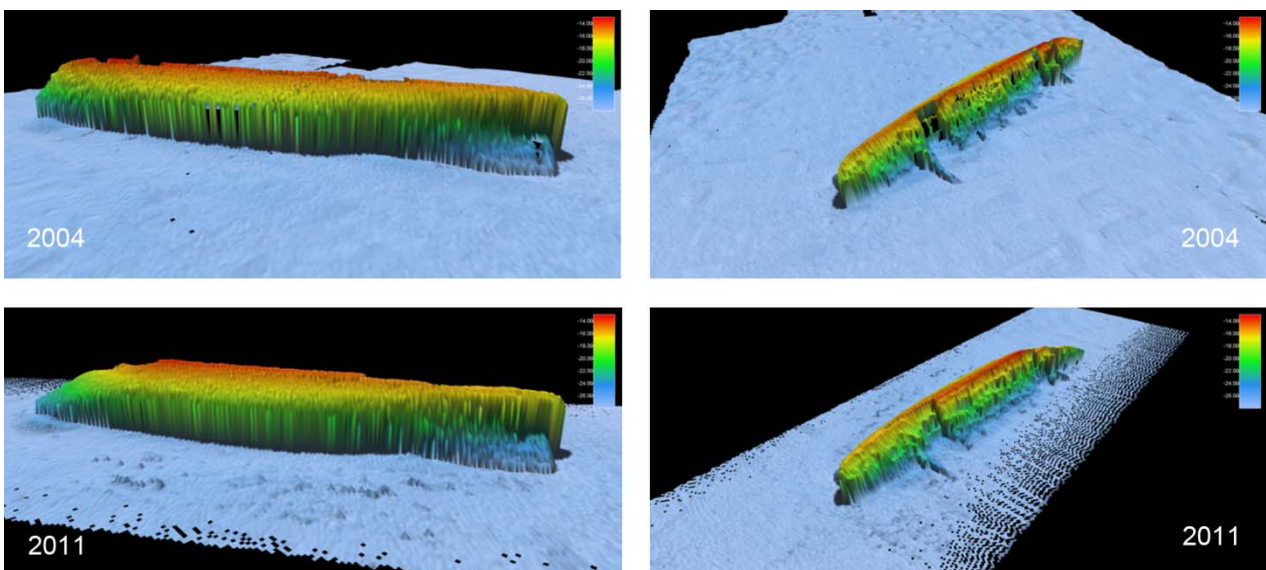
Figure 8. 3D view of the shoal-biased grid from approximately SE (left) and SSE (right), indicating debris on the seafloor to the west of to the west of the hull and to the east of the stern section of the wreck.

At present, most of the known debris field and newly identified anomalies have not been properly assessed. Their proximity to the wreck clearly suggests that they are associated with the *Yongala*, but they remain to be confirmed as archaeological or biological debris (i.e. abraded coral and shellfish cover).

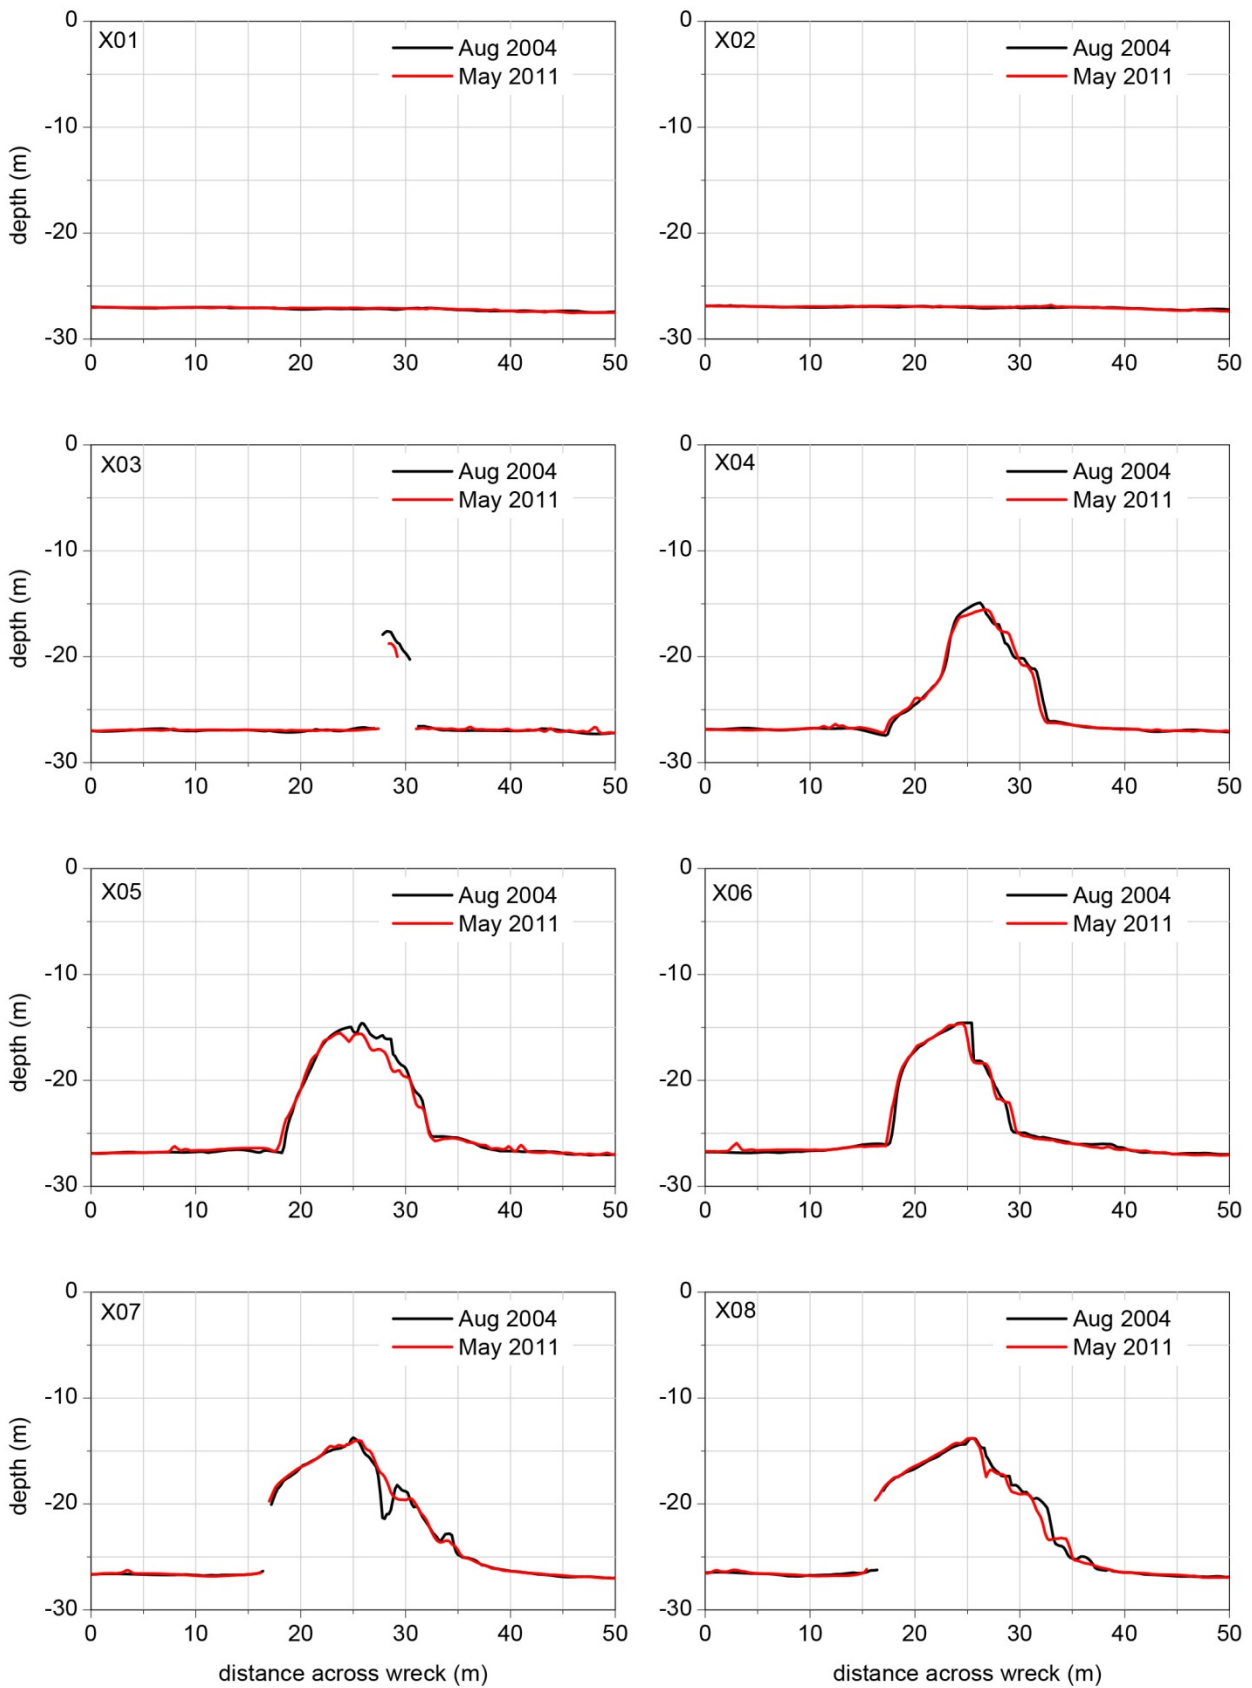
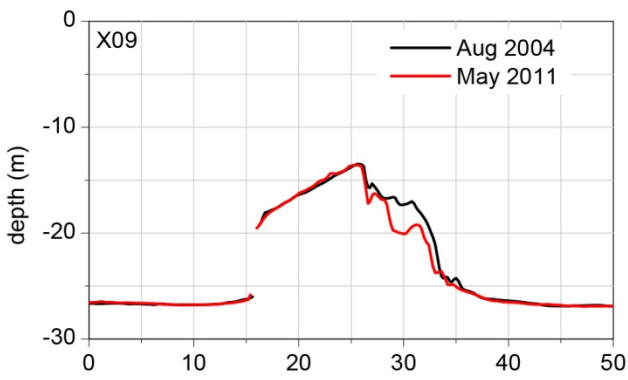
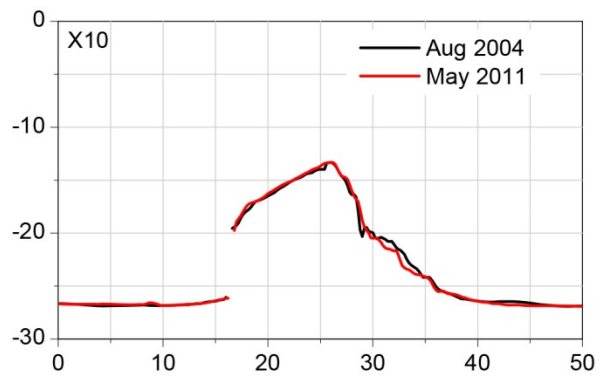
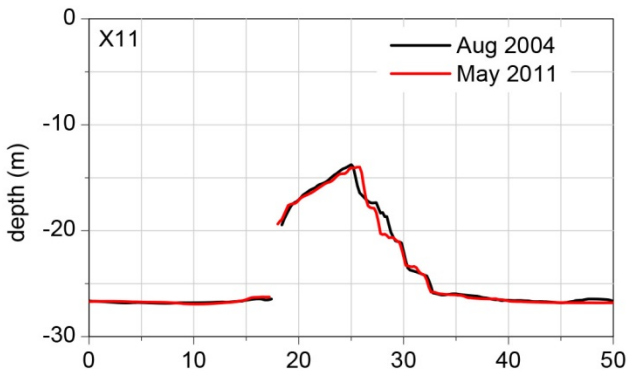
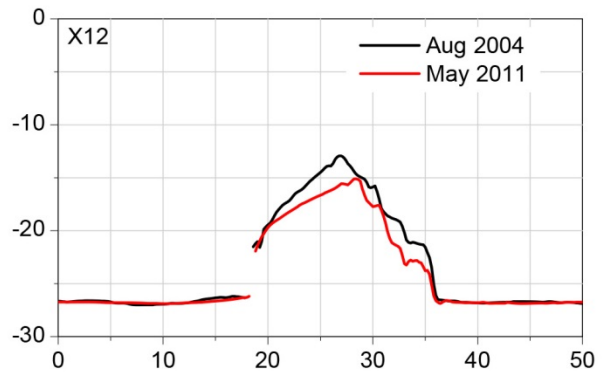
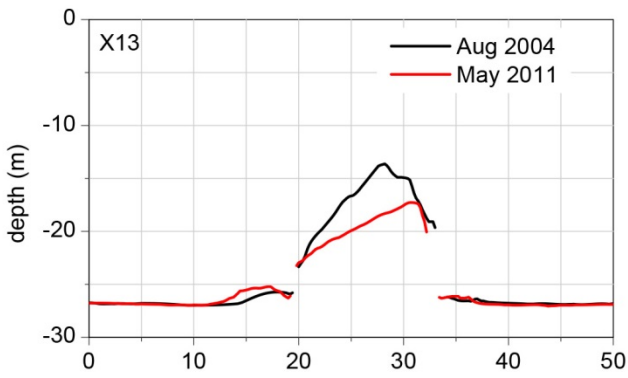
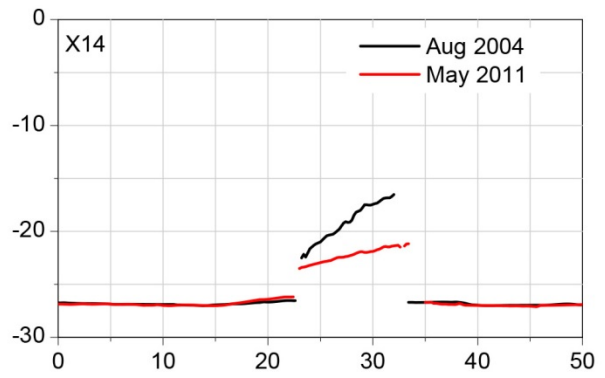
Appendix A. Sections across the SS Yongala hull in 10m intervals. Section locations are shown in Figure 5.

representing the aft 30m section of the wreck, show small, possibly rotational variations between 2004 and 2011 data.
