Rain in the Basilica: Protecting Goa's Bom Jesus from the Ravages of Climate Change

Vishvesh Prabhakar Kandolkar

Goa College of Architecture (Goa University), India

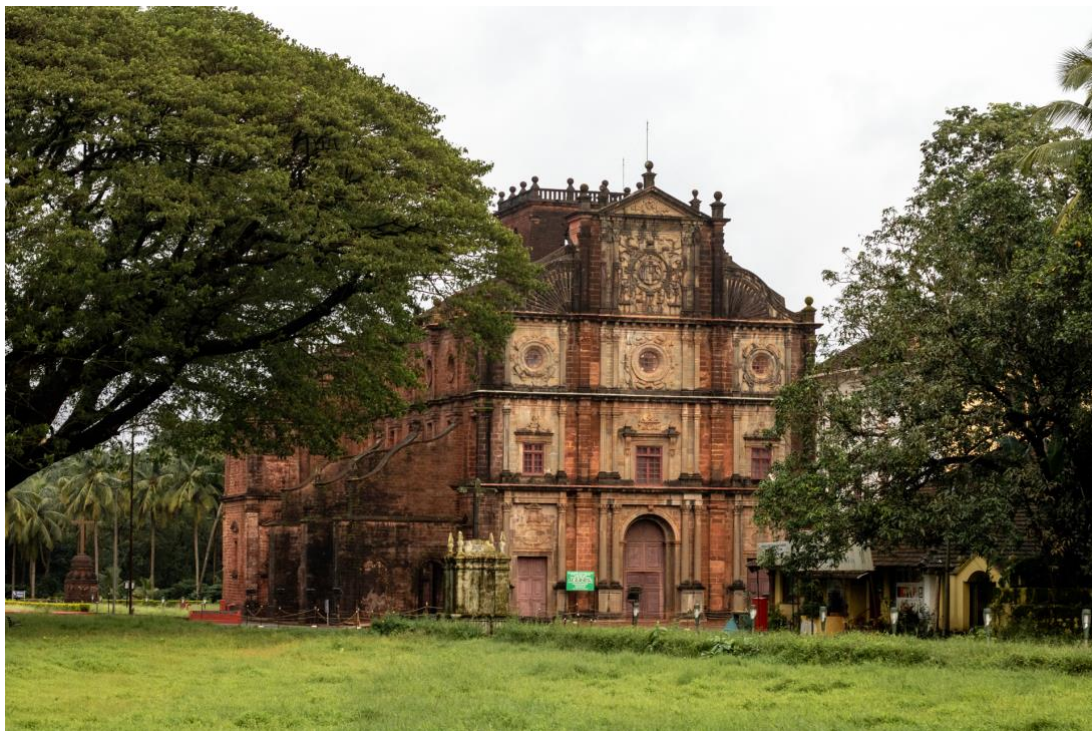
Figure 1. *Basilica of Bom Jesus*

The Basilica continues to be lashed by increasingly incessant and extremely heavy monsoonal rains, affecting the conservation of the exposed laterite walls of the church. (Author's photograph, August 2021).

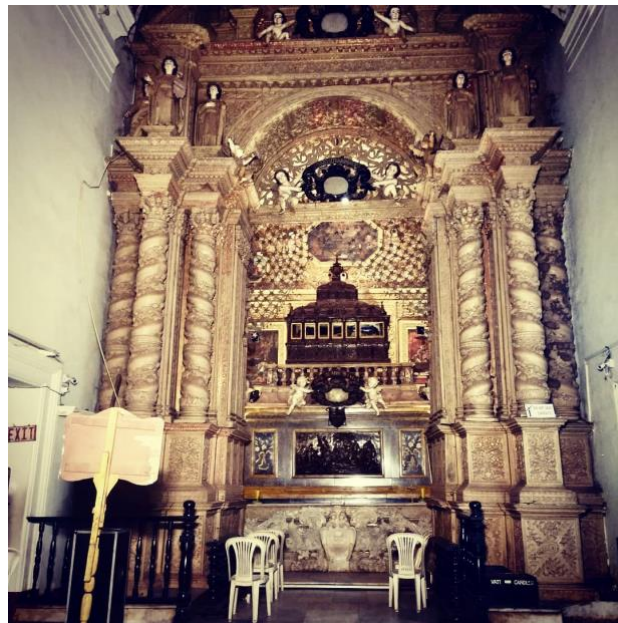
Figure 2. Tomb of St. Francis Xavier in Basilica Bom Jesus

The body of the saint is kept in a silver casket above a marble pedestal. The chapel dedicated to the saint is in the alcove of the church's right-hand side transept. Fr. Patricio mentions that the wall of the chapel was damaged due to the rains entering the Basilica in April 2020. (Photo: Lester Silveira 2020).

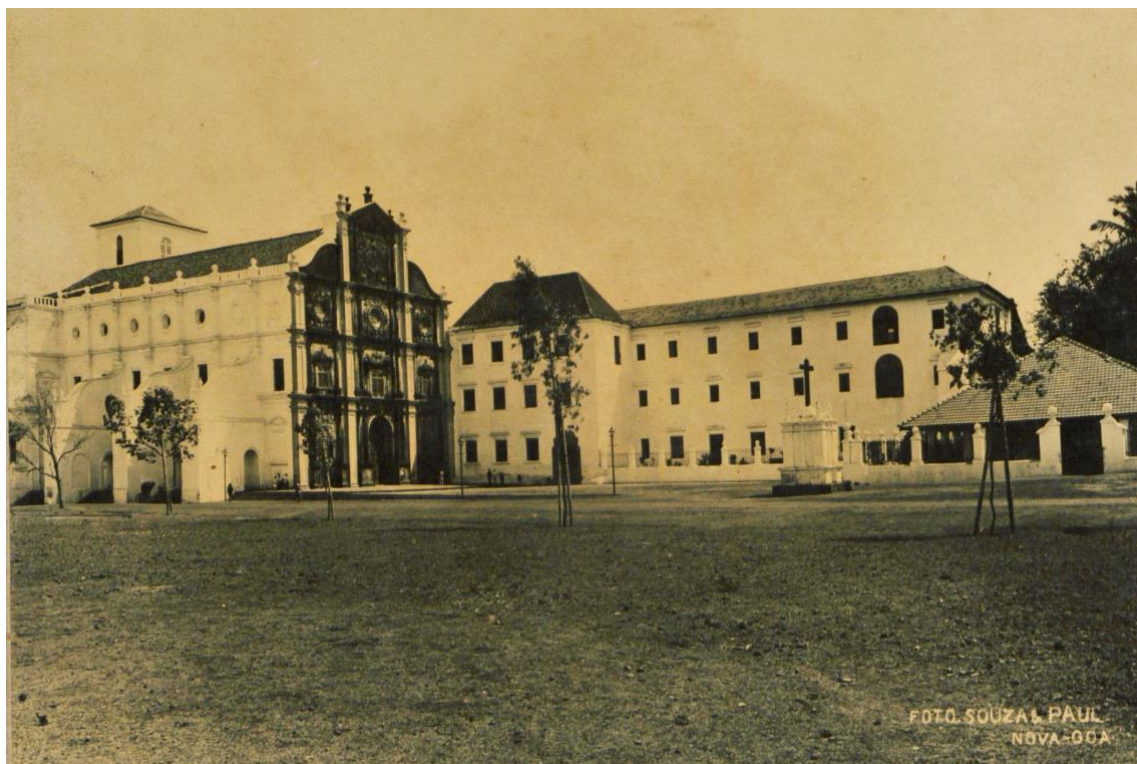
Figure 3. 1890 Photograph of the Basilica of Bom Jesus

Original lime-rendered and whitewashed Basilica of Bom Jesus in 1890, photographed by Souza and Paul. The current look of the Basilica is the result of restoration carried out by the Portuguese architect-restorer Baltazar da Silva Castro in the 1950s. Source: Souza & Paul Collection, Central Library, Goa.

responsibility of its protection. The ASI misinterprets the exposed-laterite appearance of the Basilica as belonging to the 'Portuguese' colonial period, even though the monument was rendered and whitewashed for most of its life (see Figure 3). Such simplistic categorisation of buildings based on a political timeline is problematic because the architecture of Bom Jesus did not remain the same even during the colonial period. Maintaining the exposed appearance of the Bom Jesus shows that the ASI fails to grasp the complexity of the architectural and restoration history of the monument, especially its transformation during the dictatorial period of *Estado Novo*.

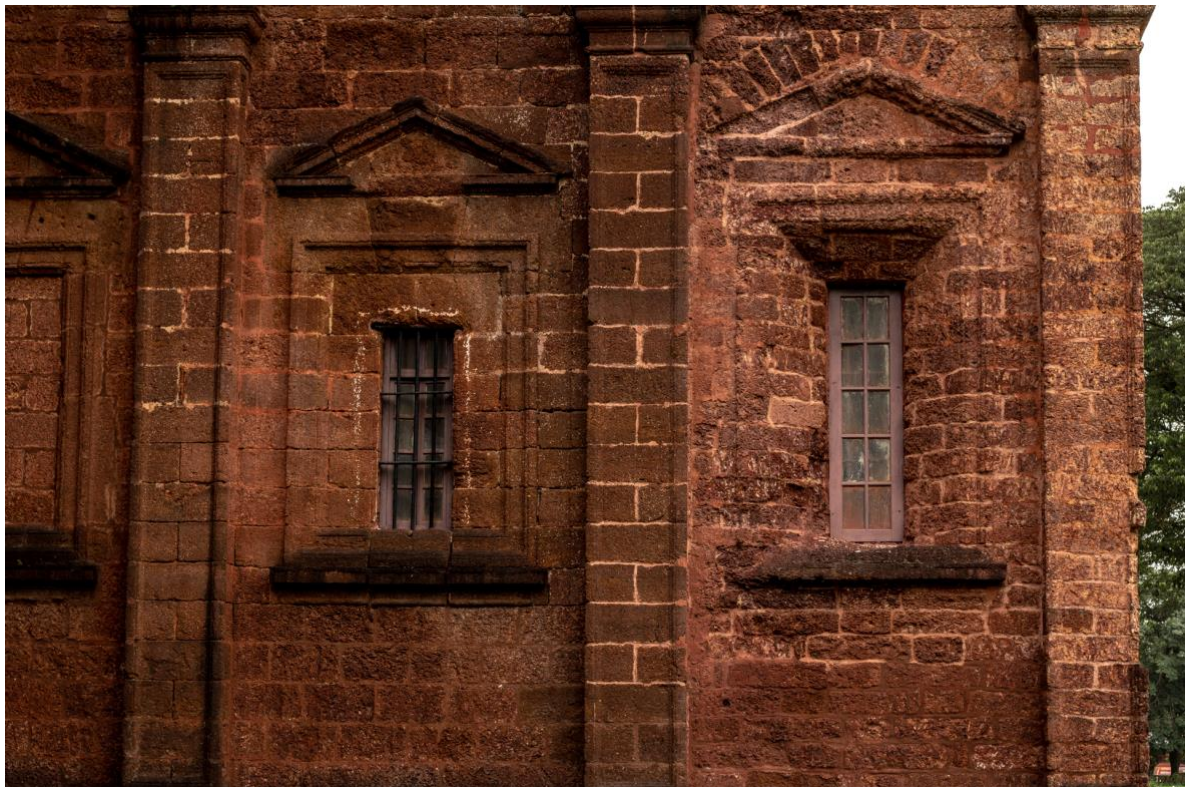
Figure 4. Closeup of the Basilica of Bom Jesus (August 2021)

Image showing the deterioration of the laterite walls, including architectural elements like pediments over windows and pilasters. Seen here, the pediment over the right-hand side window is irreversibly damaged due to the lashing of monsoonal rains. (Author’s photograph, August 2021).
