Impact of Cyclone Yasi on the Wreck of the *SS Yongala* Documented by Comparative Multibeam Bathymetry Analysis

Thomas C. Stieglitz^{1,2} and Paddy Waterson³

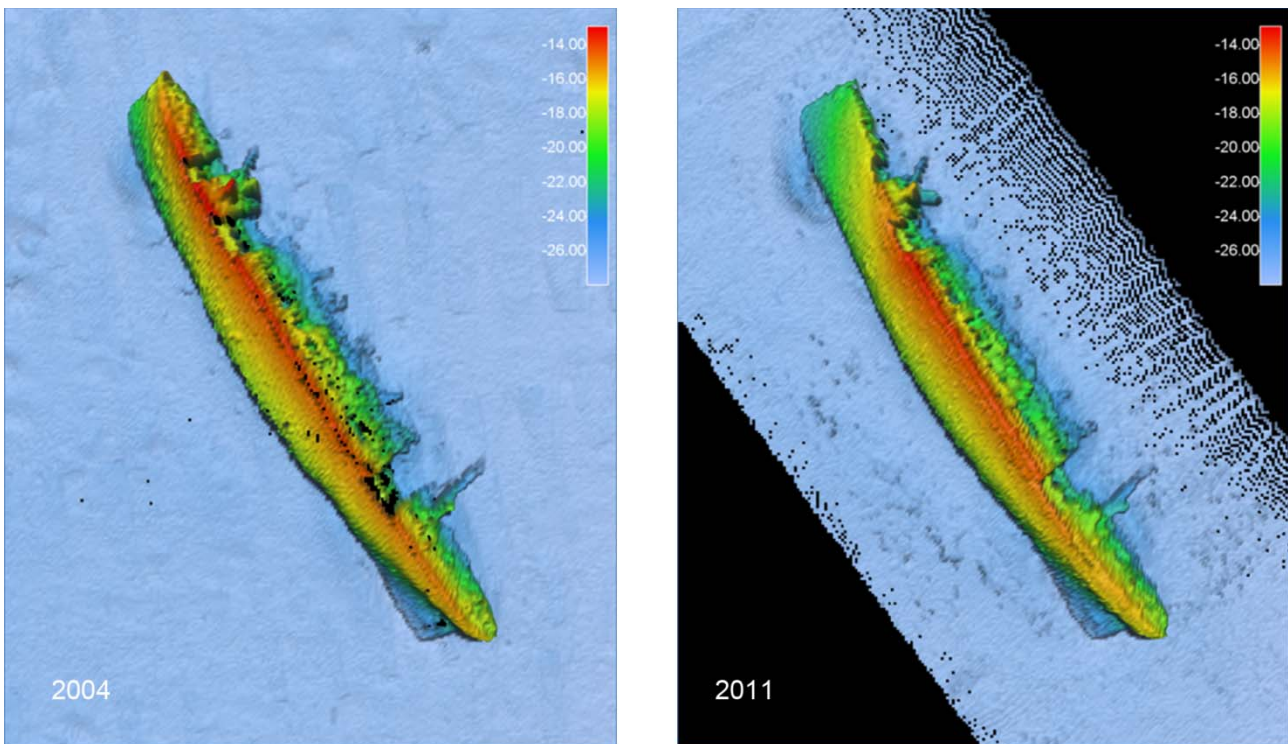
Figure 3. Plan view of color-coded sun-shaded bathymetry grid (shoal biased). The digital terrain models are displayed with an identical colour-code for comparison (legend shows depth in metres LAT).

Major features such as hull shape, cargo holds and superstructure are prominently visible in both datasets (Figure 3). The 110m-long wreck is oriented in an approximate NNW-SSE direction. Water depth of the surrounding seafloor is approximately 27m lowest astronomical tide (LAT), and the wreck rises to less than 14m depth. Overall, the position of the wreck remained unchanged. Importantly, it did not rotate or shift in X-Y direction.

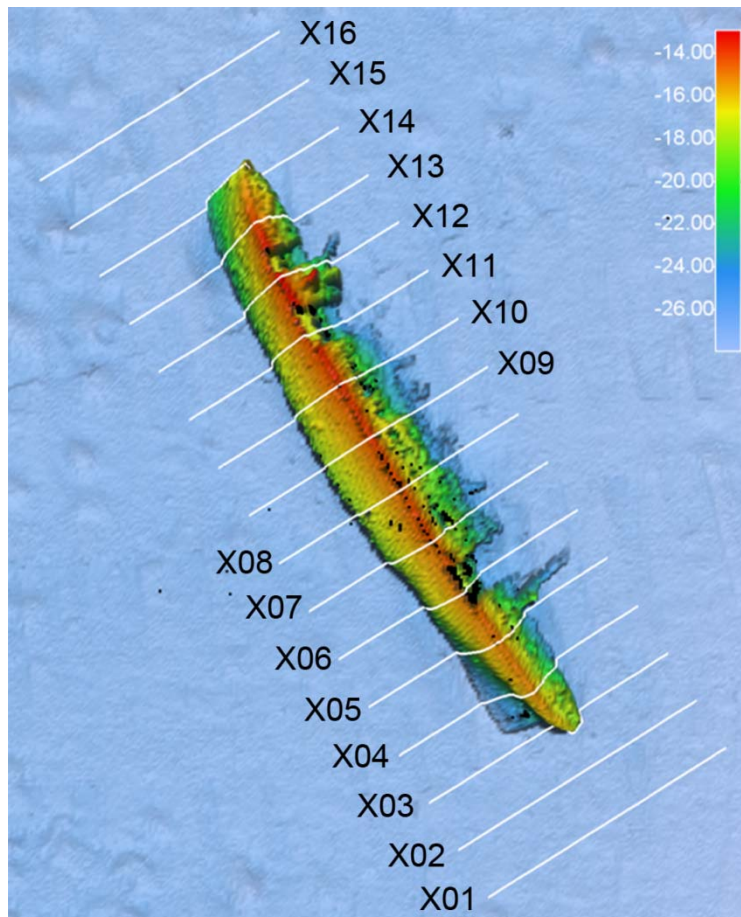
The most pronounced changes occurred in a c.35m-long section forward of the first cargo hold (highlighted in red, Figure 4). The bow at its tip has dropped in height by just over 5m. The forward section of the hull has rotated towards the east, with a pivot point located 35–40m aft of the bow (Figures 5–6). Hull cross-sections X11 to X14 in Figure 6 provide a quantitative determination of this rotation around the wreck’s axis.

Figure 5. Locations of sections across hull in 10m intervals shown in Figure 6 and Appendix A.
